DRAFT FINAL TECHNICAL MEMORANDUM

PROJECT: San Francisquito Creek **DATE:** June 5, 2023
SUBJECT: Existing Conditions Hydraulic Model Update
Post 2022 New Year's Eve Flood
PREPARED: Jack Xu, PE, CFM

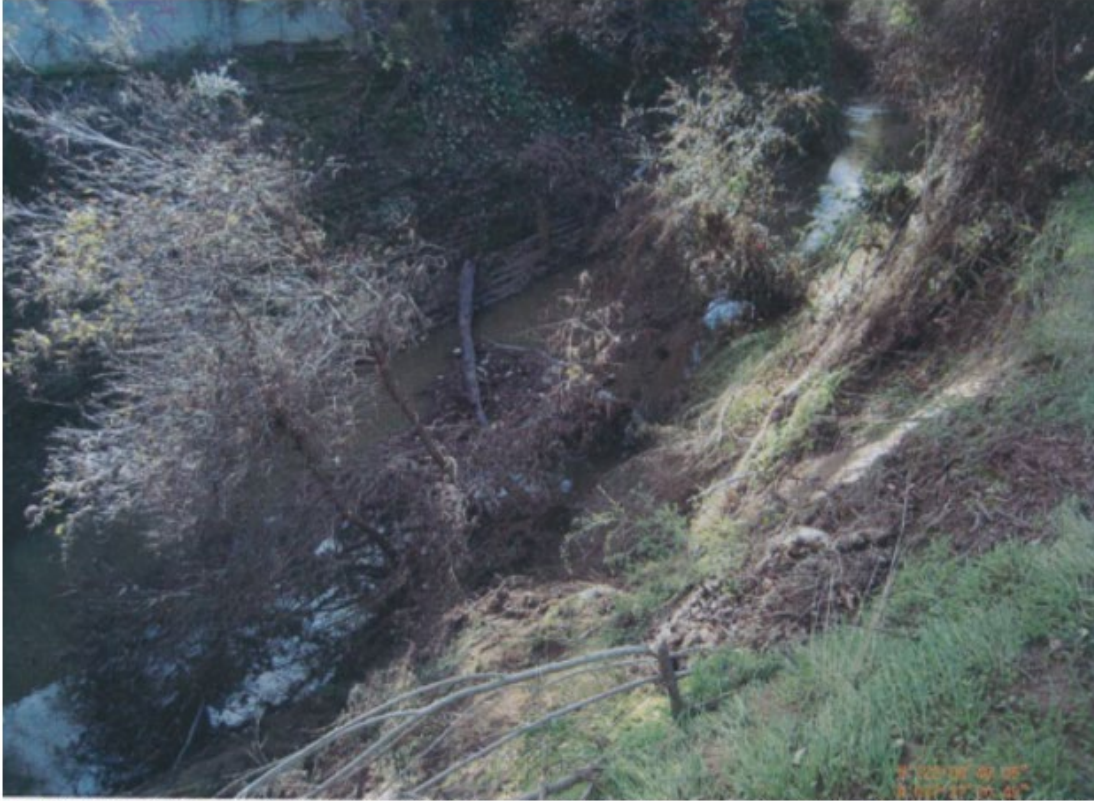
FIGURE 3: Post Flood Picture in December 2012 (Top) and December 2022 (Bottom) upstream of University Avenue.

To compare historic conditions, pictures and descriptions from Valley Water's 2012 flood report⁶ were used. Older flood reports, such as the one from 1998, do not have quality pictures to compare. Analysis does not show any significant difference in vegetation (Figure 3). In addition, Valley Water maintenance staff perform a creek walk every fall and have not flagged any significant differences in recent memory. The Creek's steep banks and frequent high velocity flows also would inhibit the establishment of long-term vegetation. All this evidence supports the conclusion that vegetation has not changed significantly.

However, the difference in observed floating debris is very stark upstream of Pope Chaucer Bridge. Figure 4 shows significantly more floating debris in the NYE flood event at a peak flow of 5,880cfs versus the 2012 flood event with a peak flow of 5,400cfs (USGS gage at Stanford). However, in the previous Figure 3, the debris remaining on vegetation limbs appear similar.

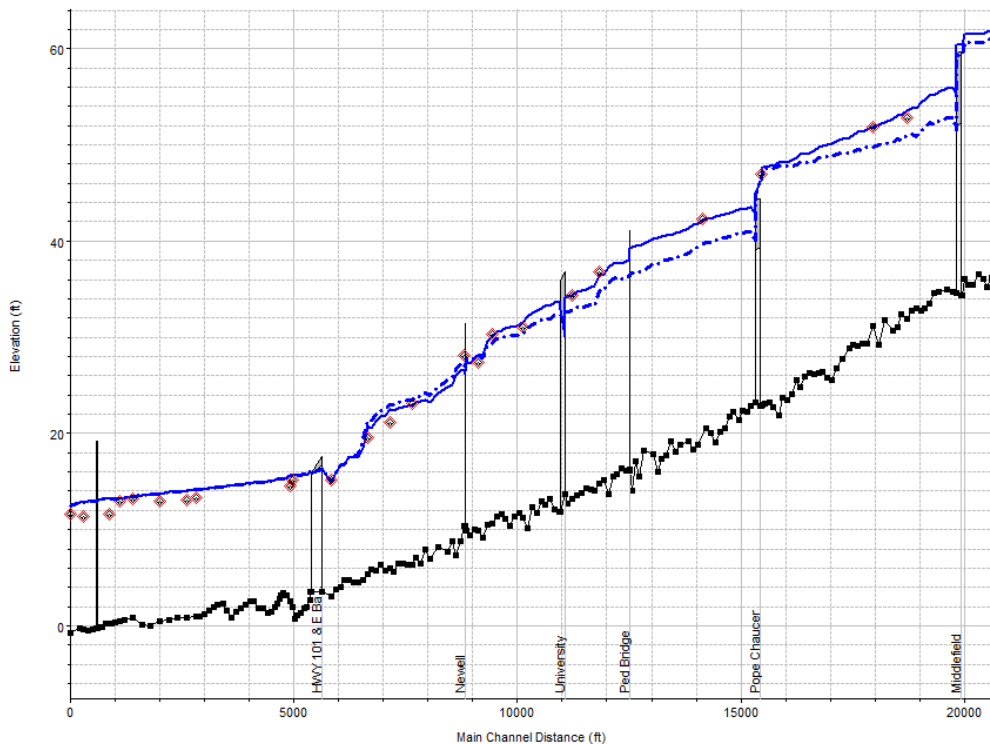
FIGURE 6: Revised Existing Conditions Model (Solid Blue), 2016 VW Model (Dashed Blue) & Observed HWMs (Red) for NYE

Roughness values were increased from the original roughness coefficient until the WSE generally matched the observed HWMs (Figure 6). This validates the 1D roughness values in the channel. In addition, overbank locations and inundations areas were also compared to validate the 2D model (Figure B-2). Flooding areas and extents generally match. Deviations due to storm drains and physical barriers (property fences and walls) are expected. For example, it is known that on the southern side of the Creek, Palo Alto storm drains mostly flow towards a pump station that was collecting overflow during the NYE storm, reducing the flood footprint. The model corroborated observations that reported little to no flooding during the NYE second peak, which reached 5,430cfs at the USGS gage.

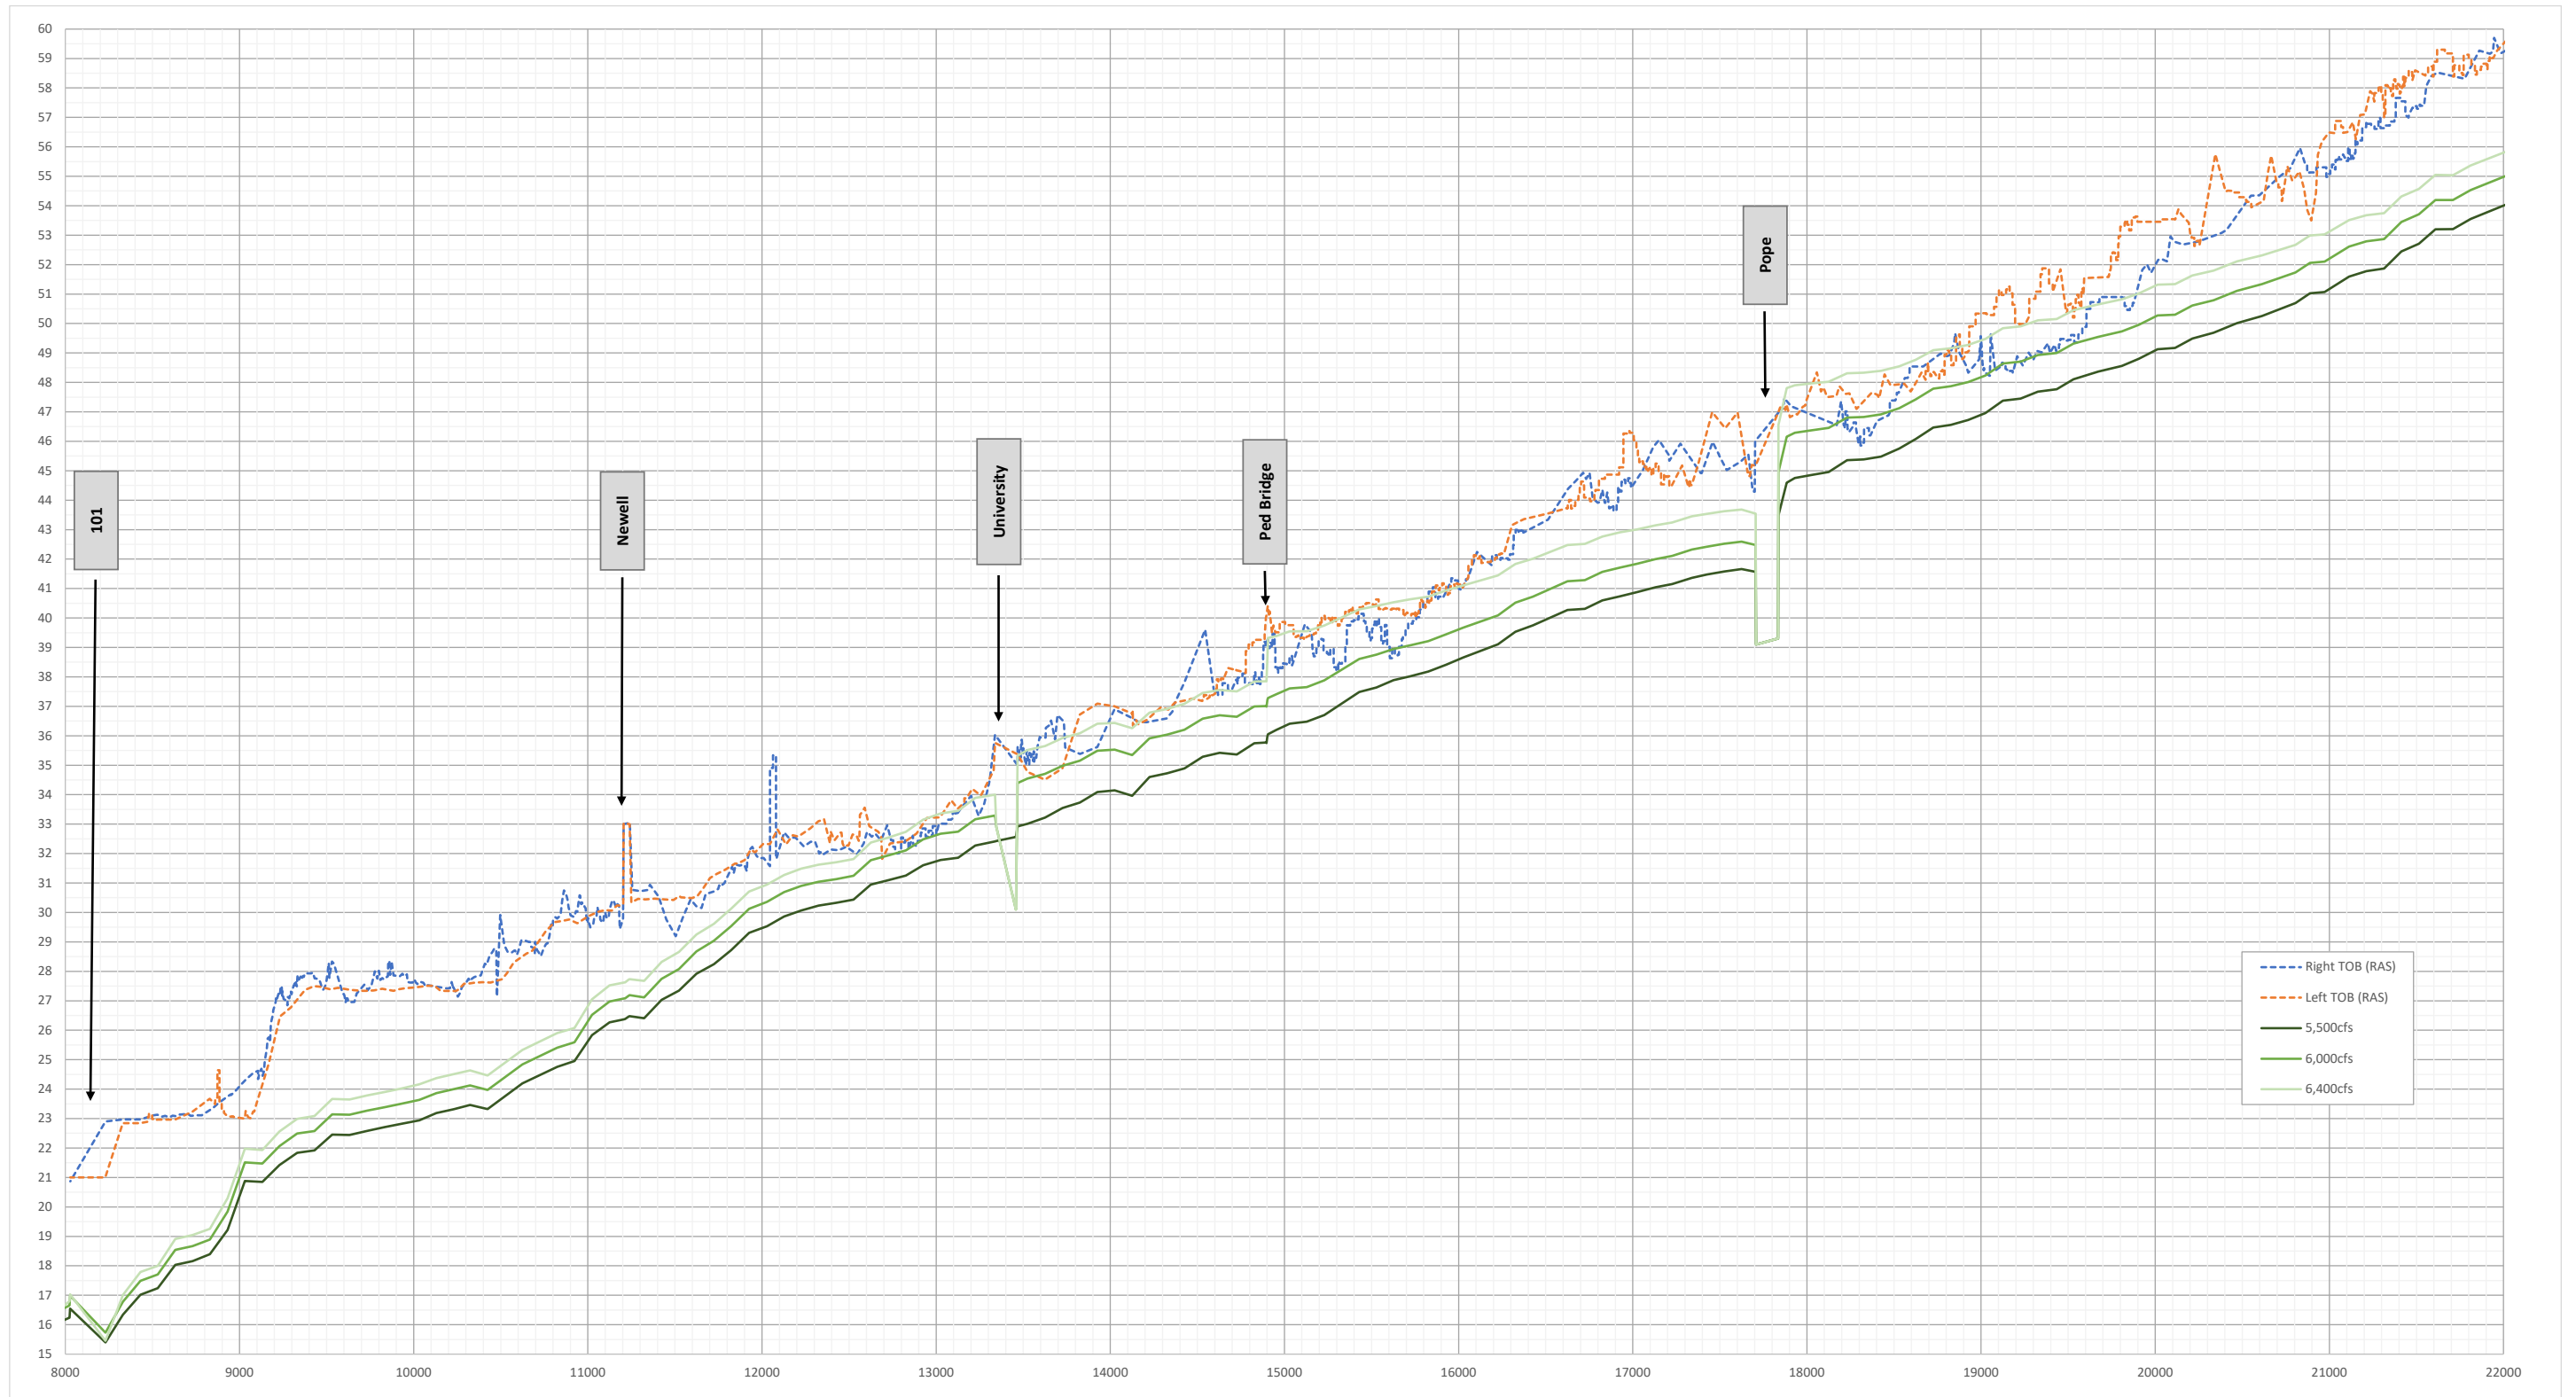
FIGURE C-1: Proposed Reach 2 Widening WSE for Select Flows with Revised Model

Resulting WSEs are plotted in Figure C-1 in the Appendix.
